LANDSLIDES AND RELATED FEATURES

OF THE WHITLEYVILLE, TENN. QUADRANGLE

by
Roger E. Thomas and Alfred R. Taylor

U.S. Geological Survey
OPEN FILE MAP 82-653(D-3)

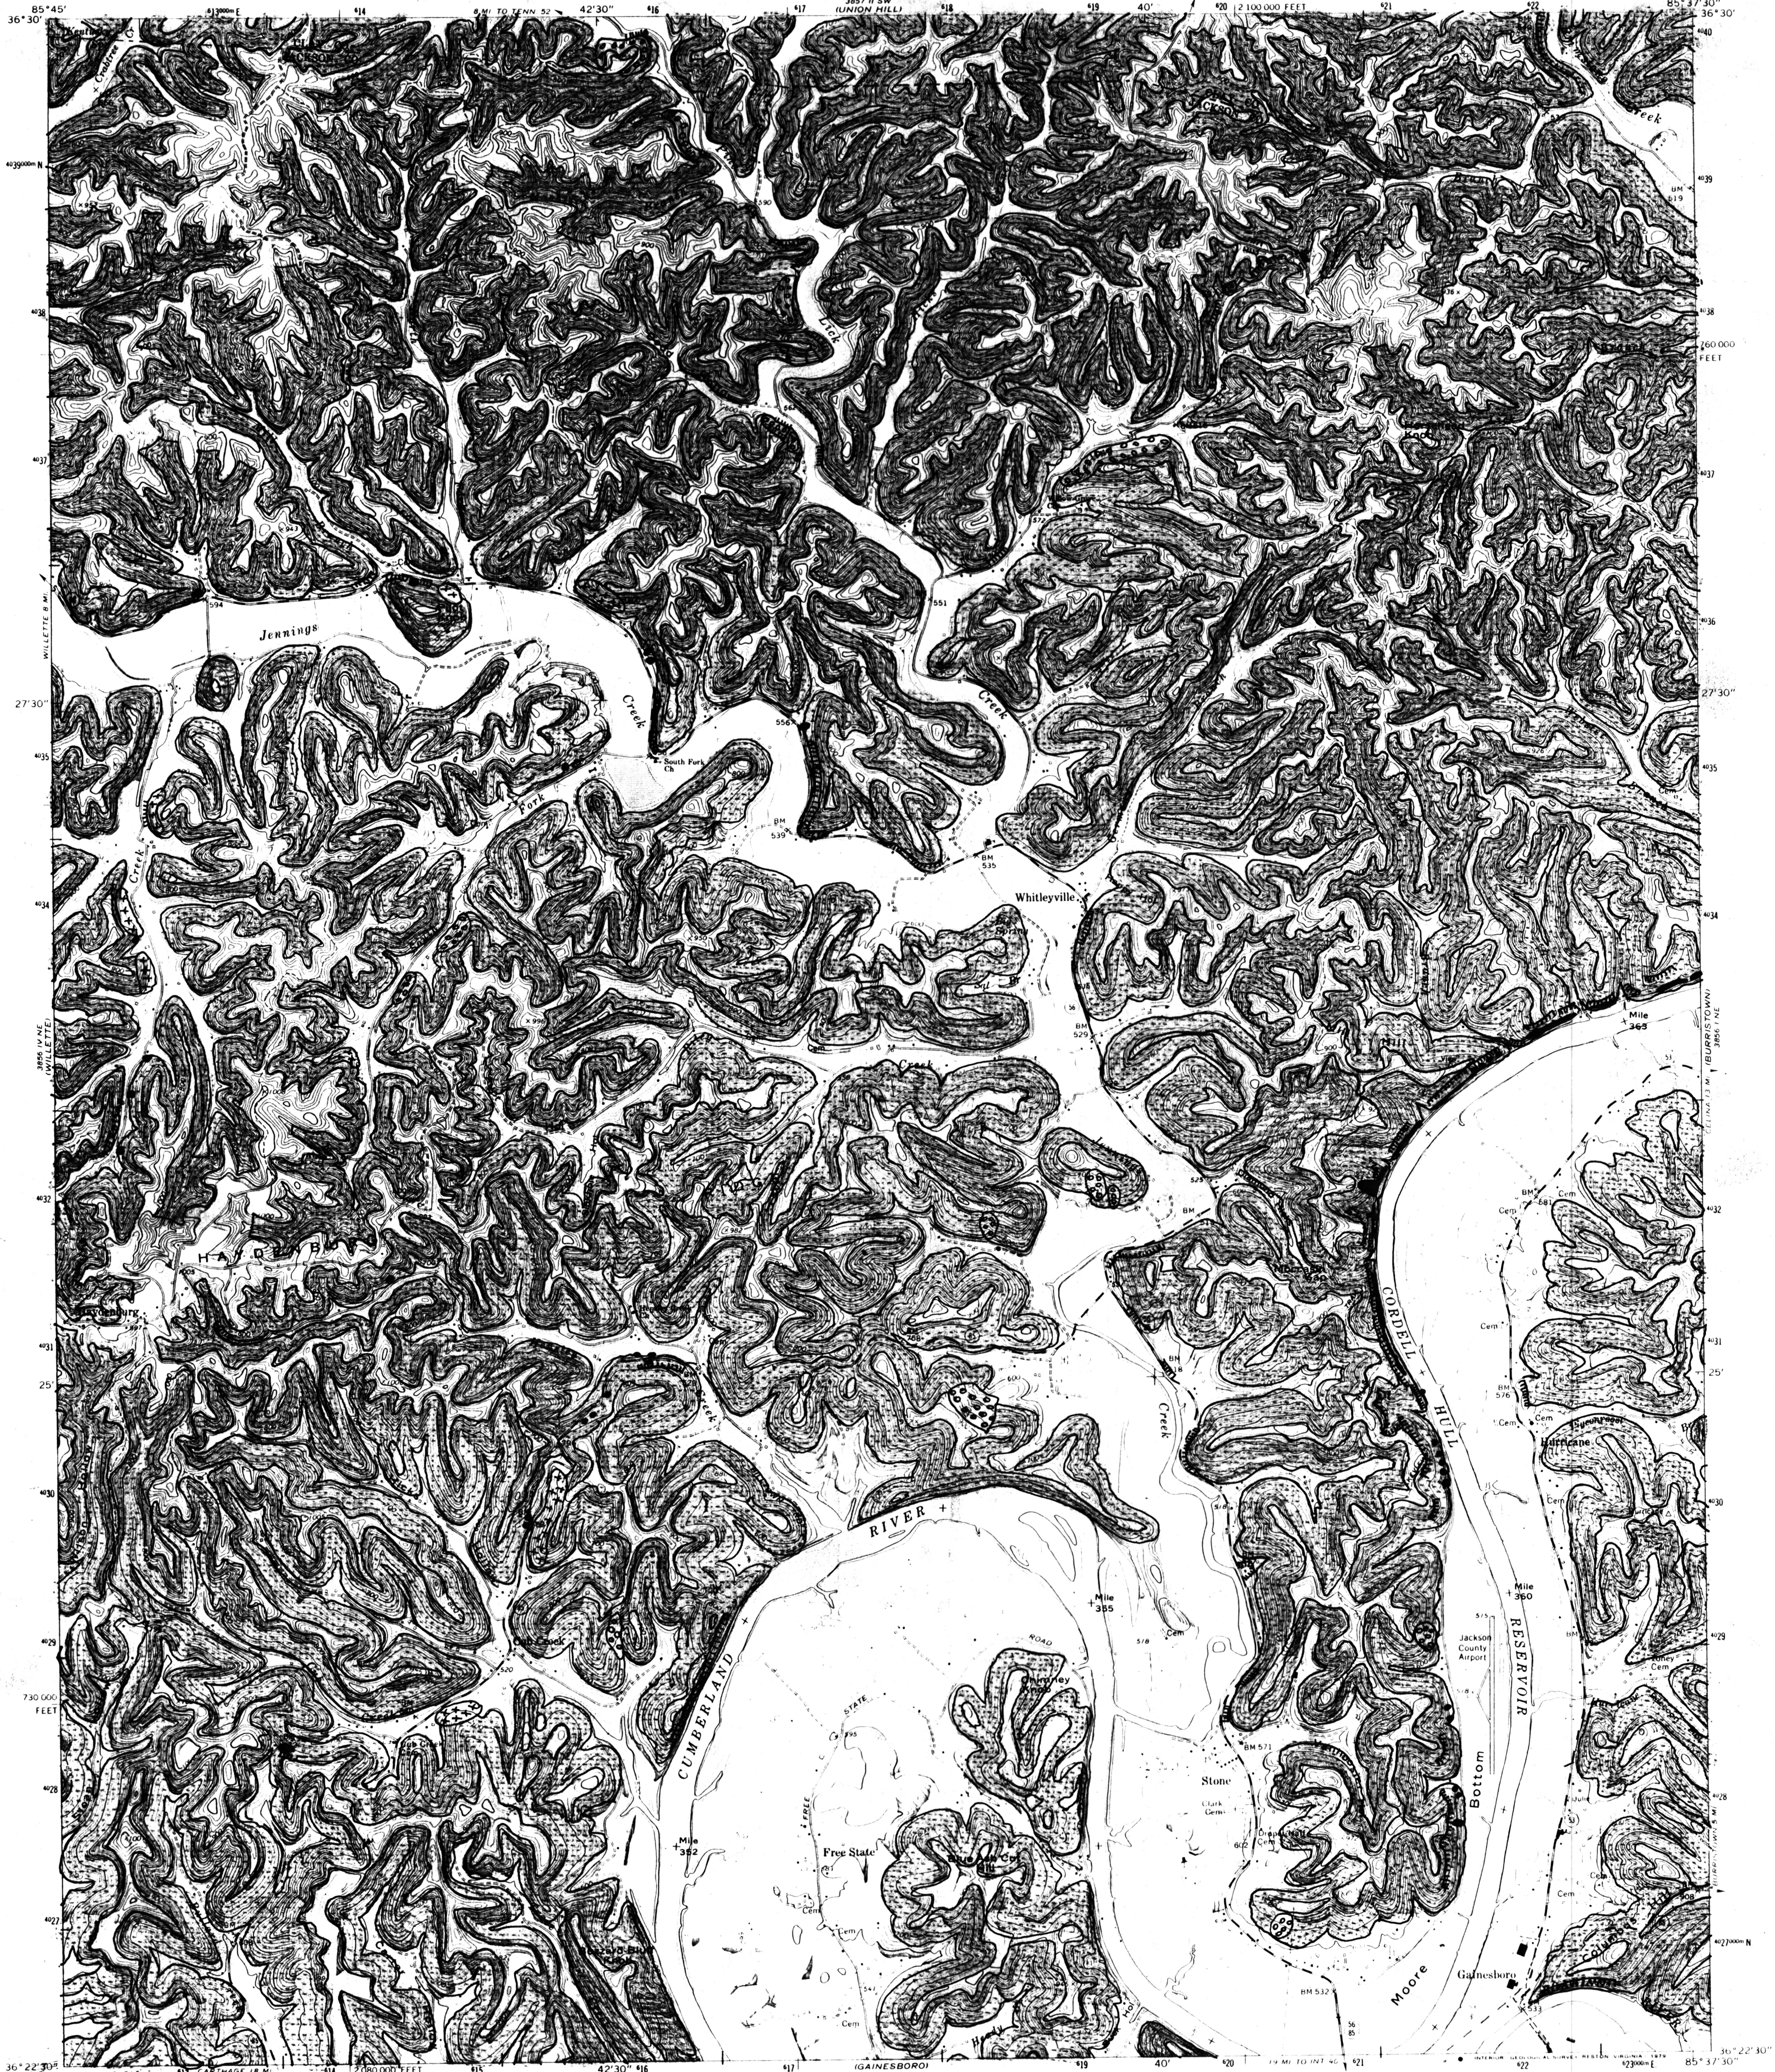
Landslides and related features interpreted
from aerial photographs:

Complex landslide composed of earthflow, debris
slide, earth and rock slump. Identified from
historical records, and from scars, debris and
other field evidence. Ground extremely unstable;
sliding accelerated by excavation, loading and
changes in drainage conditions. May include
areas with several active slides too small to
be shown separately. Questioned where doubtful.

Area of extensive hummocky ground caused by
earthflow and earth and rock slump. Lacks
clear evidence of active sliding. Relatively
stable in natural, undisturbed state,
generally not affected by small structures properly
sited in areas away from the edge of the toe;
can be reactivated by extensive, rapid exca-
vation, loading, and changes in ground water and
surface water conditions. Area of old landslide
probably includes recent ones not identified
from field evidence or otherwise documented.
Upslope boundary of landslide generally defined
by modified scarp, but downslope (toe) may be
gradational and not well defined. Questioned
where doubtful.

Valley wall along major streams with slope as
steep as 40° (85%); stony, clayey silt soil up
to 50 ft. (15 m) thick; commonly buttressed by
a terrace or bench at the toe of the slope; very
susceptible to sliding by cutting of toe area,
removal of terrace or bench, and overloading;
slide commonly activated without apparent cause.

Primarily shallow, narrow ravines and chutes with
accumulation of stony colluvium generally 10 ft.
(3 m) or less in thickness; susceptible to rapid
movement during intense rainfall. Most ravines
and chutes designated show evidence of former
debris flows and avalanches.

Steep, locally vertical, natural and man-made
slopes and cliffs, 15 ft. (4.5 m) or more high;
formed dominantly of sandstone, limestone, sandy
shale, mudstone and claystone. Interbedded mud-
stone, claystone and shale weather rapidly leaving
sandstone and limestone rock faces unsupported.

Soil and rock similar to that involved in land-
slides elsewhere in map area; primarily areas
underlain by claystone, mudstone and shale
associated with other rock types. Rock weathers
rapidly on exposure forming clayey soil highly
susceptible to sliding. Includes coves (U-shaped,
shallow valleys) containing thick layers of clayey
soil that are very susceptible to sliding where
excavation breaks continuity of slope and where
overloaded by artificial fill.

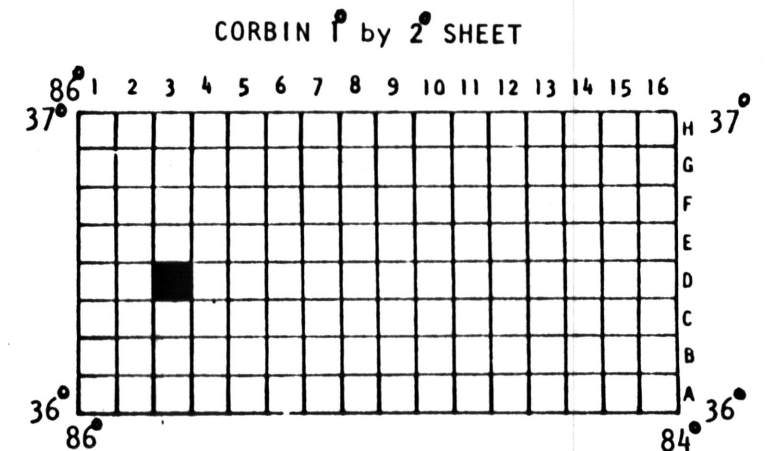
The first five digits of the open file number designate the
specific 1:250,000 scale map sheet of which this quadrangle
is a part. The last two digits designate the position of the
quadrangle in a subdivision of the 1:250,000 scale map based
on rows and tiers shown in the diagram to the right. The
location of this quadrangle is shown by the black square.
